Manhole Inspection Summary

Manhole # S39C2_019MH

Location Address: **4033 6th St**

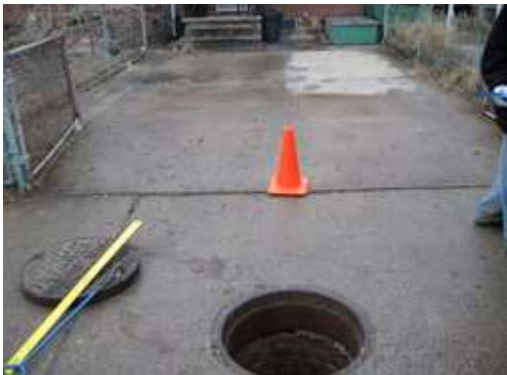
Location View

6th-Brooklyn alley

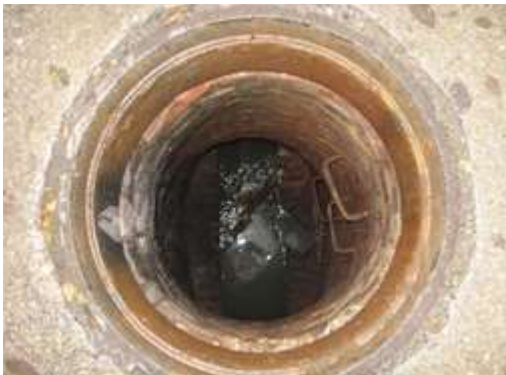
Top View

Steps Count: **5** Missing: **0** ☒ **Corroded**

steps

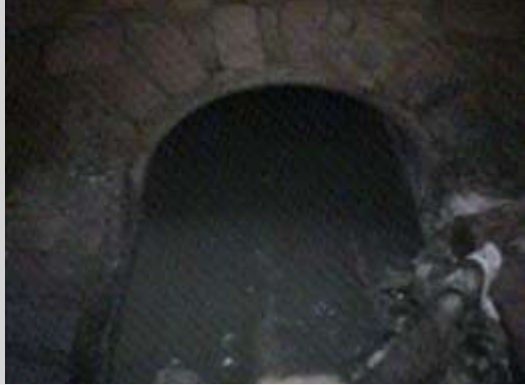
12 O'Clock Outflow

18 in. Circular Gravity Sewer
Pipe Out @ 12 O'Clock

Pipe Height: **18** (in.) Rod and Bar (Angled)
Pipe Material: **Clay** ☐ Pipe Lined
Invert Depth: **10.81** (ft.) Flow Characteristics: **Fast**
Deposits: ☒ None ☐ Mud ☐ Sludge ☐ Debris ☐ Grease
Silt Depth: (in.) Deposits Extent:
Infiltration: **None** Pipe Seal Cond: **Sound**

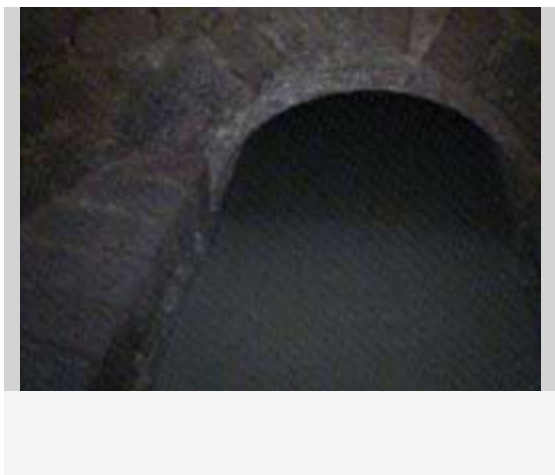
6 O'Clock Inflow

18 in. Circular Gravity Sewer
Pipe In @ 6 O'Clock

Pipe Height: **18** (in.) Rod and Bar (Angled)
Pipe Material: **Clay** ☐ Pipe Lined
Invert Depth: **10.80** (ft.) Flow Characteristics: **Fast**
Deposits: ☒ None ☐ Mud ☐ Sludge ☐ Debris ☐ Grease
Silt Depth: (in.) Deposits Extent:
Infiltration: **None** Pipe Seal Cond: **Sound**
